SHEPHERD
HOME REPORT

81 EARN CRESCENT
DUNDEE
DD2 4BS

Energy Performance Certificate (EPC)

Single Survey

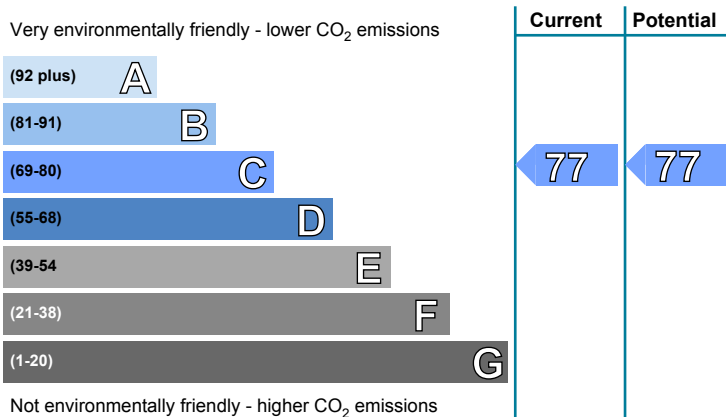
Environmental Impact (CO₂) Rating

This graph shows the effect of your home on the environment in terms of carbon dioxide (CO₂) emissions. The higher the rating, the less impact it has on the environment.

Your current rating is **band C (77)**. The average rating for EPCs in Scotland is **band D (59)**.

The potential rating shows the effect of undertaking all of the improvement measures listed within your recommendations report.
