movemachine | HOME REPORT

Single Survey

Property address	10 Pitfour Street Dundee DD2 2NW
Customer	Mr & Mrs Hughes
Customer address	c/o Baillie Shepherd 37 Union Street Dundee DD1 4BS
Prepared by	Graham & Sibbald
Date of inspection	7th December 2020

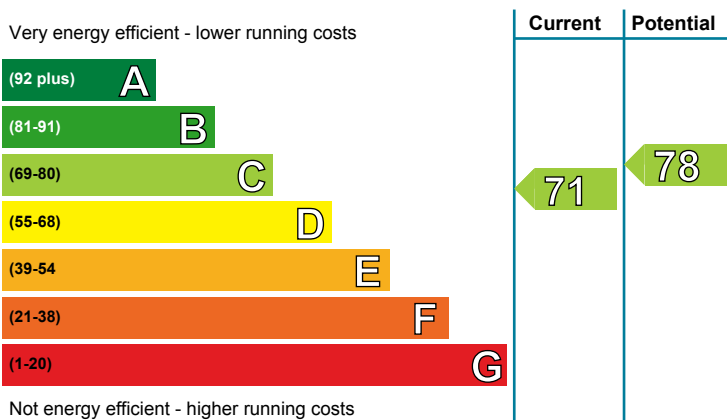
Energy Efficiency Rating

This graph shows the current efficiency of your home, taking into account both energy efficiency and fuel costs. The higher this rating, the lower your fuel bills are likely to be.

Your current rating is **band C (71)**. The average rating for EPCs in Scotland is **band D (61)**.

The potential rating shows the effect of undertaking all of the improvement measures listed within your recommendations report.
